# **Upper Rapid Creek Subwatersheds Riparian Project Stream Assessment Report**

**Developed for the  
Portneuf Soil and Water Conservation District**

**Prepared by  
Justin W. Krajewski  
Water Quality Resource Conservationist  
Idaho Soil Conservation Commission  
Pocatello, Idaho**

**March 2002**

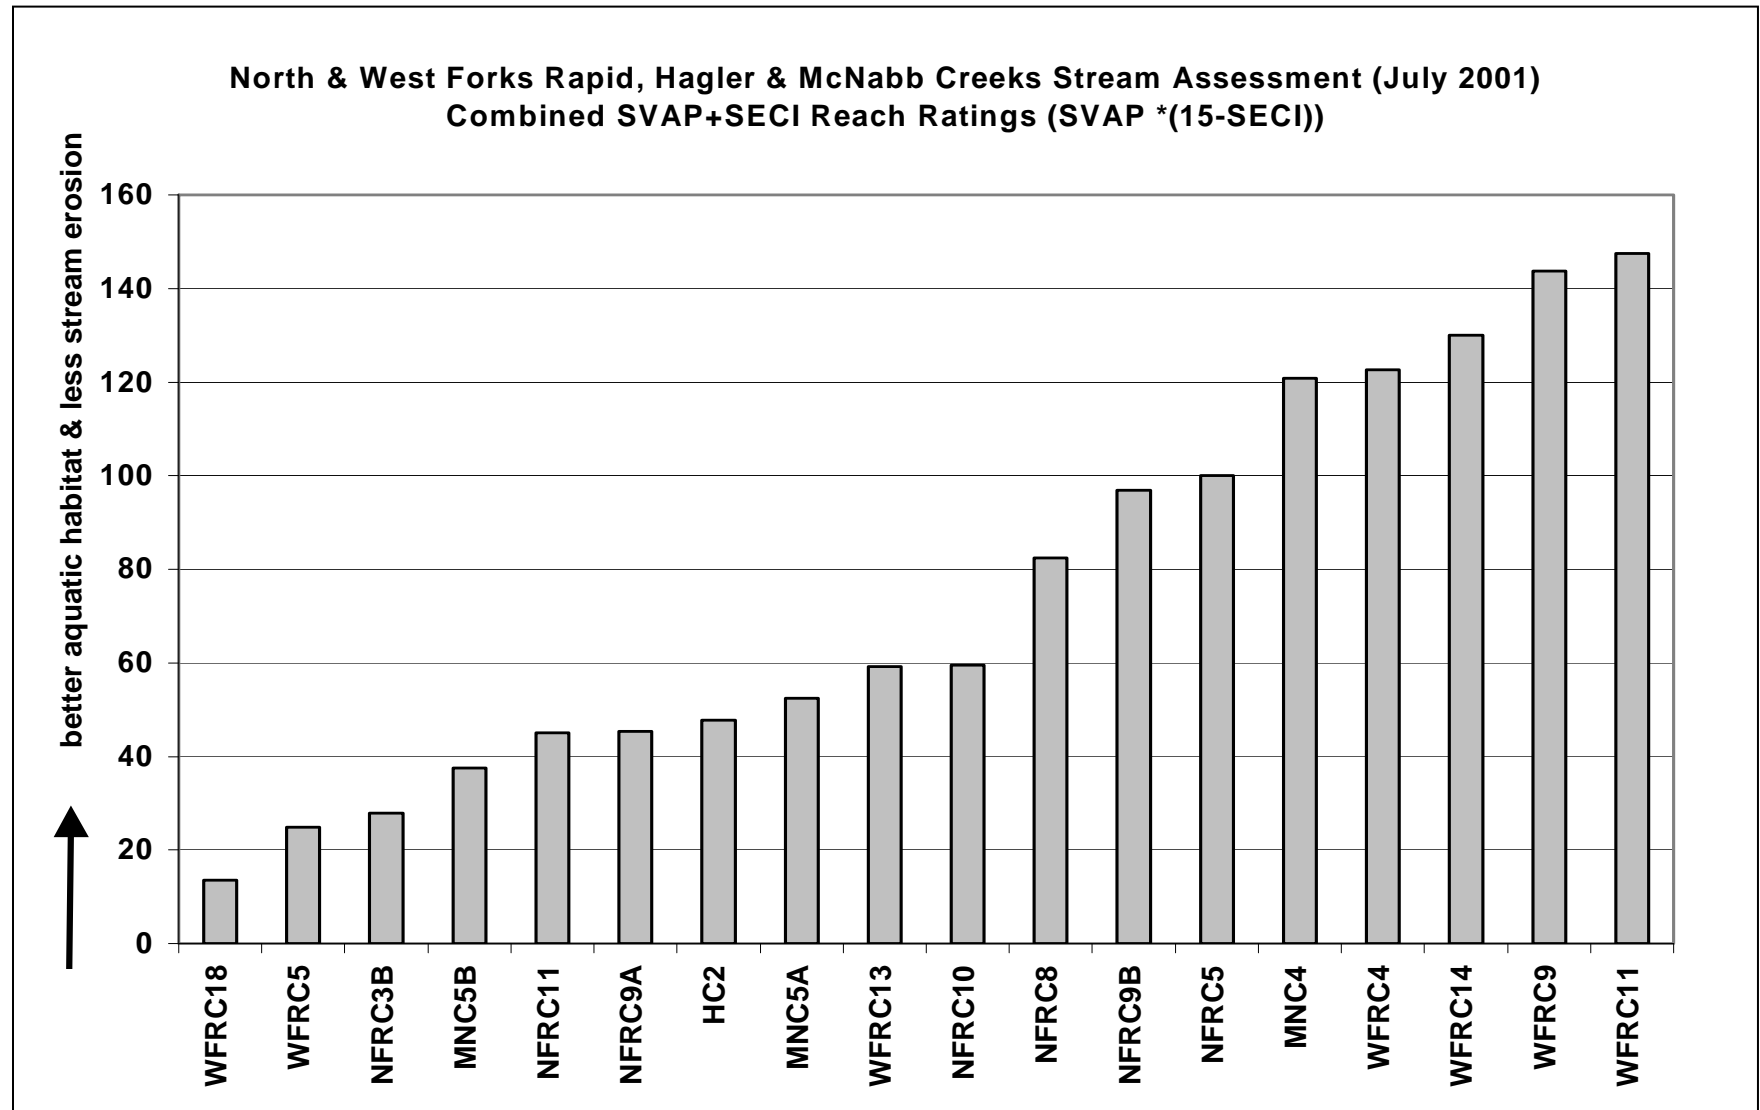
Figure 8. North and West Forks Rapid, Hagler and McNabb Creeks SVAP/SECI Combined Chart

PSWCD, NRCS, ISCC and IASCD staff performed the assessment from July 24<sup>th</sup> to July 27<sup>th</sup>, 2001. Thirty-seven reaches were delineated on sixteen miles of streams within the subwatersheds. The teams assessed 18 reaches or 6.5 miles of creeks. These were the only reaches where permission was granted by the landowners to conduct the assessment. The teams did not assess other reaches because permission was not granted. The teams completed field sheets while at each reach. Photos were taken at each reach to document conditions during the assessment. Results for each reach are shown in Table 8. About 3.2 miles of North Fork Rapid Creek, 2.4 miles of West Fork Rapid Creek, 0.8 miles of McNabb Creek and 0.1 miles of Hagler Creek were assessed. The combined SVAP and SECI scores of the assessed reaches are shown in Figure 8. This allows the reaches to be evaluated based upon both habitat suitability and erosion condition.

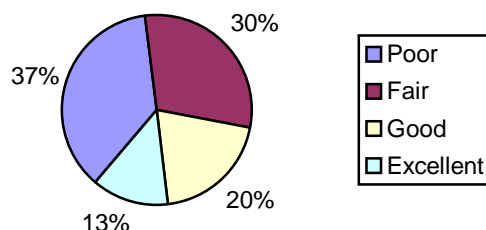
**Figure 9. Percent of Assessed Stream Miles for SVAP Rating Categories**

SVAP results show that 37% or 2.4 miles of the assessed reaches were in poor condition, 30% or 2.0 miles of the assessed reaches rated in fair condition, while 20% or 1.3 miles of the assessed reaches rated in good condition and 13% or 0.8 miles rated in excellent condition. These results are Figure 9. SVAP average scores of each assessed reach are shown in Table B-1 and Figure B-1.

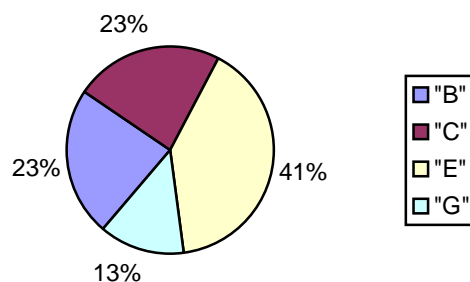
**Figure 10. Percent of Assessed Stream Miles for Rosgen Stream Types**

The stream classification of the assessed stream miles estimated that about 23% or 1.4 miles were "B" stream type, 23% or about 1.4 miles were "C" stream type, 41% or 2.4 miles of the assessed reaches were "E" stream type and 13% or 0.8 were "G" type. Specific definitions for the stream types can be found in the glossary. Approximately 0.5 miles of the assessed reaches were not classified due to inaccessibility. These results are shown in Figure 10. Stream types for assessed reaches are shown in Table B-2.

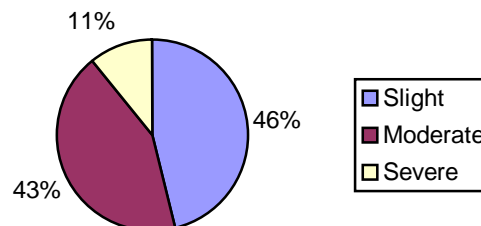
**Figure 11. Percent of Assessed Stream Miles for SECI Categories**

SECI results reveal that of the 6.5 miles of assessed stream miles about 46% or 3.0 miles had slight erosion. While 43% or 2.8 miles rated in moderate erosion condition and 11% or 0.7 miles rated in the severe erosion category. These results are shown in Figure 11. SECI average scores of each assessed reach are shown in Table B-3 and Figure B-2. Stream erosion rates for each reach are shown in Figure B-3.
